Question 10: What causes metal-catalyzed coking (MCC) that obstructs catalyst circulation in CCR reformers? What actions do you take to mitigate MCC formation?

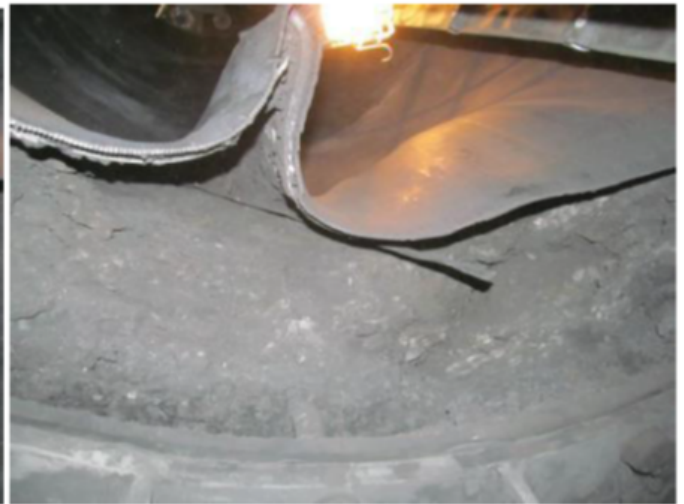
Picture-2(b): Last panel of outside reactor grid found fully bulged with huge coke build up

A joint root cause analysis with Licensor confirmed presence of Fe and carbon graphite (high carbon content) in the coke samples. During cleaning of the scallops, presence of lot of hard shining coke (metallic coke) was observed along with soft coke. It was concluded that coke build up in reactors/scallops/grids may have taken place due to metal catalyzed coking considering problem with DMDS dosing pump during initial year of commissioning as well as due to other reliability issues like frequent trip of recycle gas compressor. The presence of metallic coke in reactors may have acted as nuclei and further catalyzed the coke growth during recycle gas failure.

Carry out emergency catalyst circulation in case of unplanned trip of the Recycle Gas compressor to relieve the mechanical stress built up due to difference in the thermal expansion coefficient between catalyst and reactors internals.

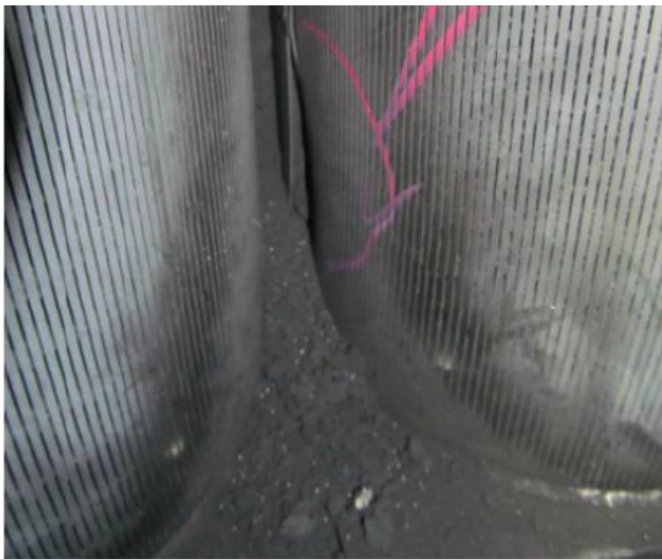
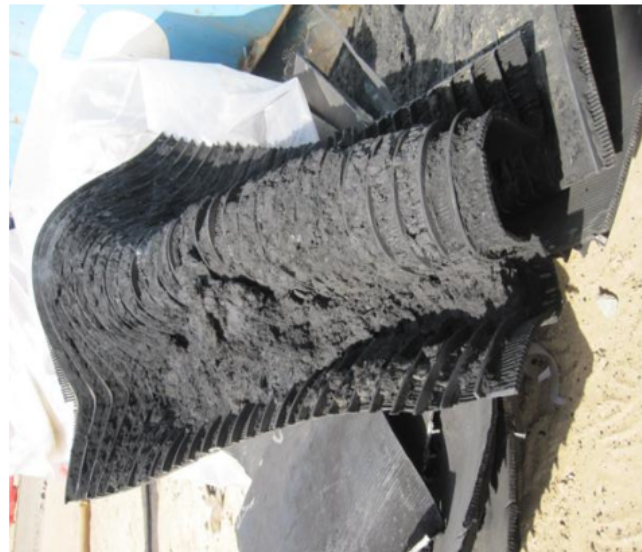
Picture-3(a): Shiny coke between and inside scallops leading to bulging and fish mouth cracks

Maintain sulfur level 0.3 to 0.5 ppmw on CCR feed to be substantiated by presence of detectable amount of H₂S in recycles gas and 100-150 ppmw of 'S' on catalyst sample.

Operate Naphtha Hydro-treating (NHT) unit to remove essentially all of the sulfur and other contaminants in the feed. Inject DMDS in CCR feed through dedicated facility to maintain recommended range of sulfur.

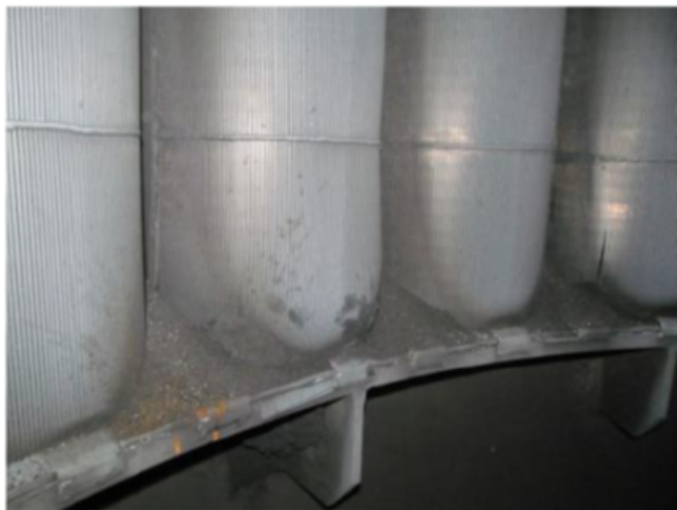
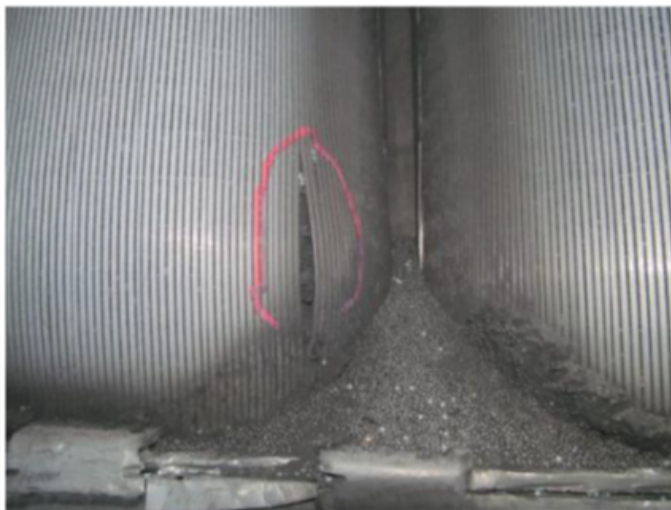
Picture-3(b): Shiny coke between and inside scallops leading to bulging and fish mouth cracks
