Question 67: Have you experienced coking or other fouling of reboilers in naphtha distillation service (splitter, debutanizer, etc.)? If so, what operational or design changes did you implement to eliminate this problem?

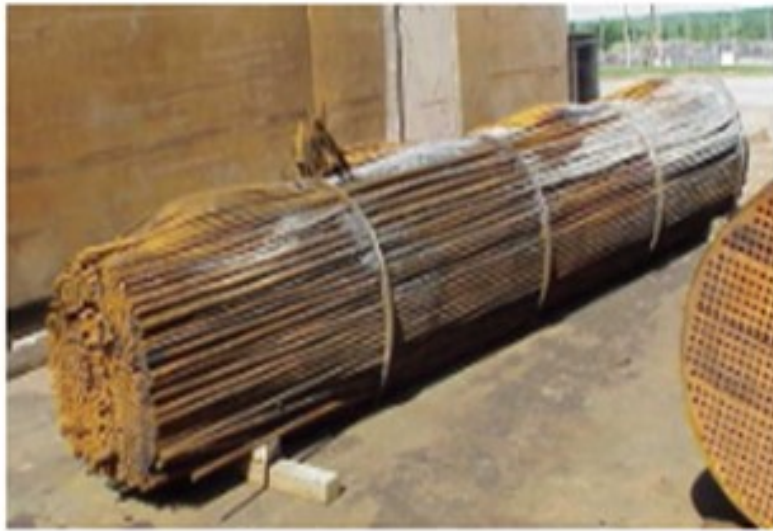
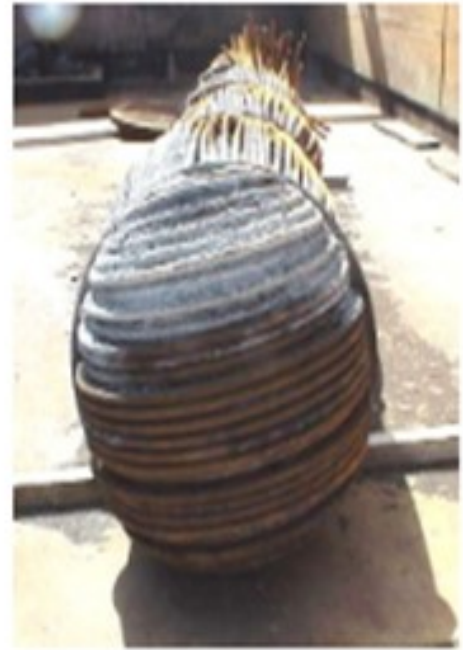
- The Debutanizer Reboilers are two kettle reboilers with U-tube bundles.
- Debutanizer bottoms flows through the shell side and is heated with Heavy Cycle Oil on the tube side.
- The shells and original bundles were carbon steel.
- History of tube leaks, but no records of significant shell-side fouling.
- Due to leak history purchased new chrome bundles for installation.
- At shutdown, very difficult bundle extraction.
- Extensive coke formation within the bundles bulged the tops rows of tubes into the shell cavity. •Shell-side fouling was found largely in the top 1/3 of the bundles.

- Fouling was believed to be caused by iron-catalyzed diolefin polymerization that eventually became coke and was a function of
 - Reboiler tube wall temperature

- Diolefin concentration

- Iron concentration

- We eliminated issue by lowering HCO temperature some and changing metallurgy to 9Cr bundles. It has been four years since bundle replacement without performance problems. We will confirm during next year's turnaround.
