**Question 36: Which refinery water sources do you accept for hydrotreater water wash (e.g., stripped fractionator overhead water, stripper sour water, etc.)? What are typical water quality guidelines?**

**JEFFREY MUELLER** (Marathon Petroleum Company)

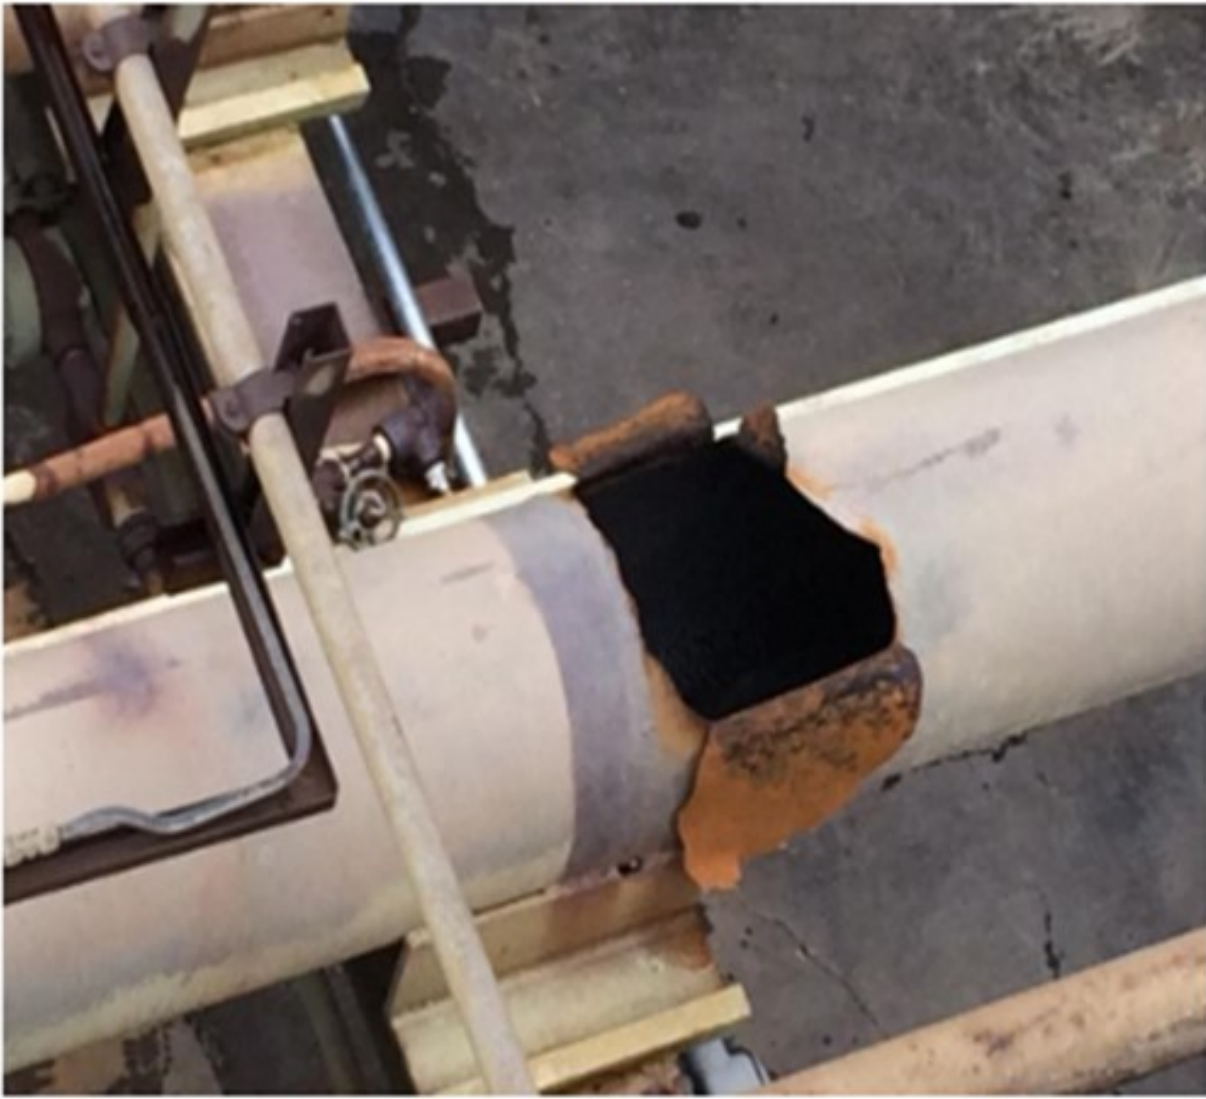
On April 9, 2015, a failure occurred on the top of a horizontal section of reactor effluent piping of a naphtha hydrotreater. The escaping stream of hydrocarbon was estimated to be 70 to 80feet high, and the sound of liquid hydrocarbon release made communications in the immediate area difficult. Fortunately, the unit operators were able to shut down the heaters without incident. Figure 1 illustrates the piping failure associated with this incident.

**Figure 1. Reactor Effluent Piping Failure at MPC NHT**

The piece of piping that failed was located directly downstream of the feed/effluent exchangers and a continuous waterwash injection point, upstream of the reactor effluent air coolers. The system operated at 320 psig and 280°F, with no prior history of leaks. The process, at this point, contained 0.2 mol% H<sub>2</sub>S, 0.001 mol% NH<sub>3</sub>, and 0 to 4 ppm chloride in the makeup hydrogen. These conditions are not severe by hydrotreater standards.

The failure was internal corrosion due to the condensation of HCl on the vapor space of the pipe. Some of the causal factors in this incident relate to the waterwash design (though this was not the exclusive cause). The presence of water with inadequate mixing created an extremely corrosive condition in the vapor space of the horizontal pipe. A couple physical factors related to the waterwash contributed to this inadequate mixing:

\*The water was injected through low velocity quills.

\*Water was injected upstream of a non-freedraining low point with long horizontal line.

\*Typically, waterwash is injected immediately upstream of the REACs. In this case, there was a long horizontal run of piping immediately downstream of the injection that does not allow for adequate mixing.
