Question 94: What is your experience regarding corrosion of hexmesh anchorage in regenerators using non-phosphate bonded abrasion resistant lining materials?

Tom Lorsbach (UOP)

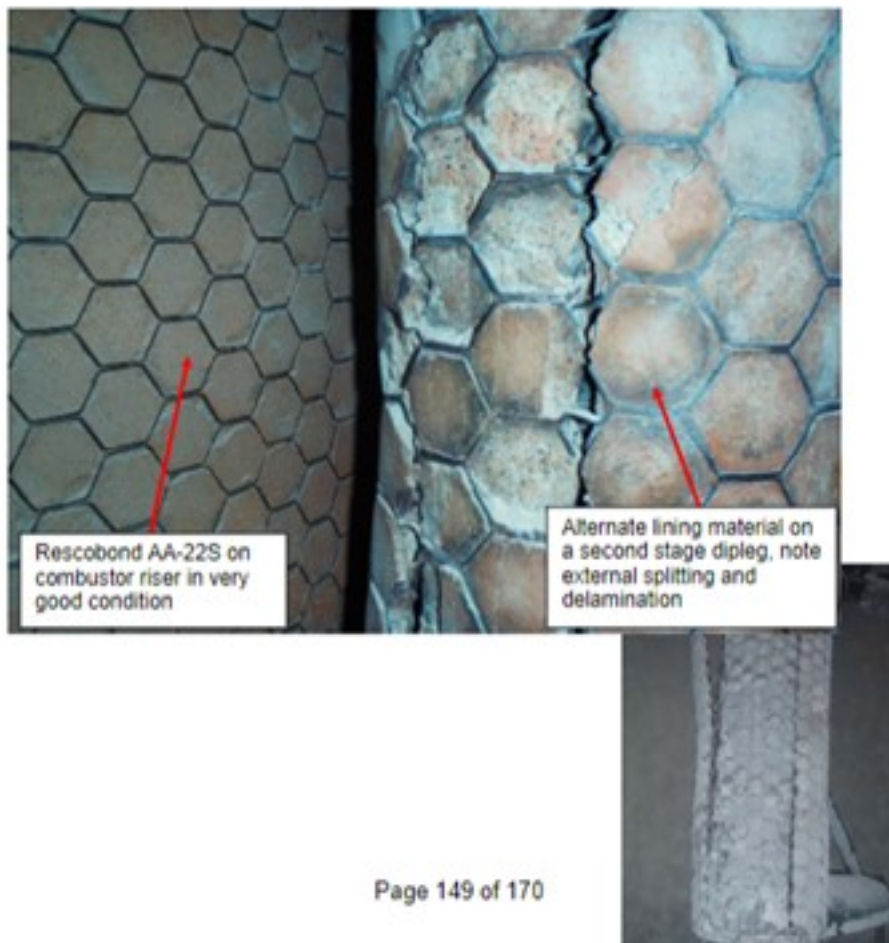
The slide on screen shows both categories of abrasion resistant materials side by side in a new full burn FCC unit. This FCC unit started up in February 2008 and processes virgin HVGO feed containing about 2.5 wt% sulfur. The pictures shown were taken in July 2011 after about 2.5 years of operation. The pictures show Rescobond AA-22S on the exterior of the regenerator combustor riser right next to an Alternate refractory material installed on the exterior of a regenerator second stage cyclone dipleg. The internal refractory linings of the cyclones were also in very poor condition as shown in the second picture.

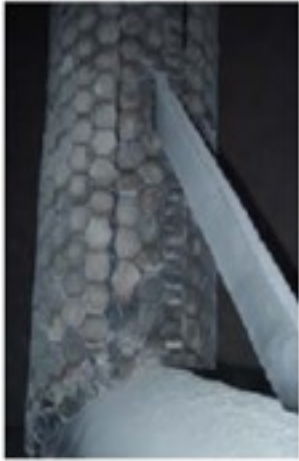
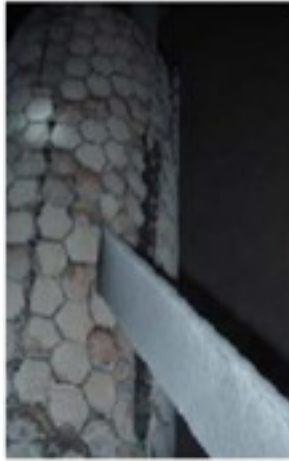
Alternate refractory lining failure due to under-lining corrosion on exterior of regenerator cyclone diplegs.

On the basis of the strong empirical correlation between lining failures and use of Alternate refractory materials and the lack of a clear solution to the problem, UOP has revised its abrasion resistant lining project specifications and now lists only Rescobond AA-22S for use in regenerator abrasion resistant linings. This under-lining corrosion has not been seen at the lower temperature reducing conditions in the reactor and several Alternate materials are cited as approved for use in FCC reactor abrasion resistant linings.
