**Question 31: What is the panel's experience with temperature excursions (regeneration and otherwise) leading to the catalyst or equipment damage in reforming and isomerization units?**

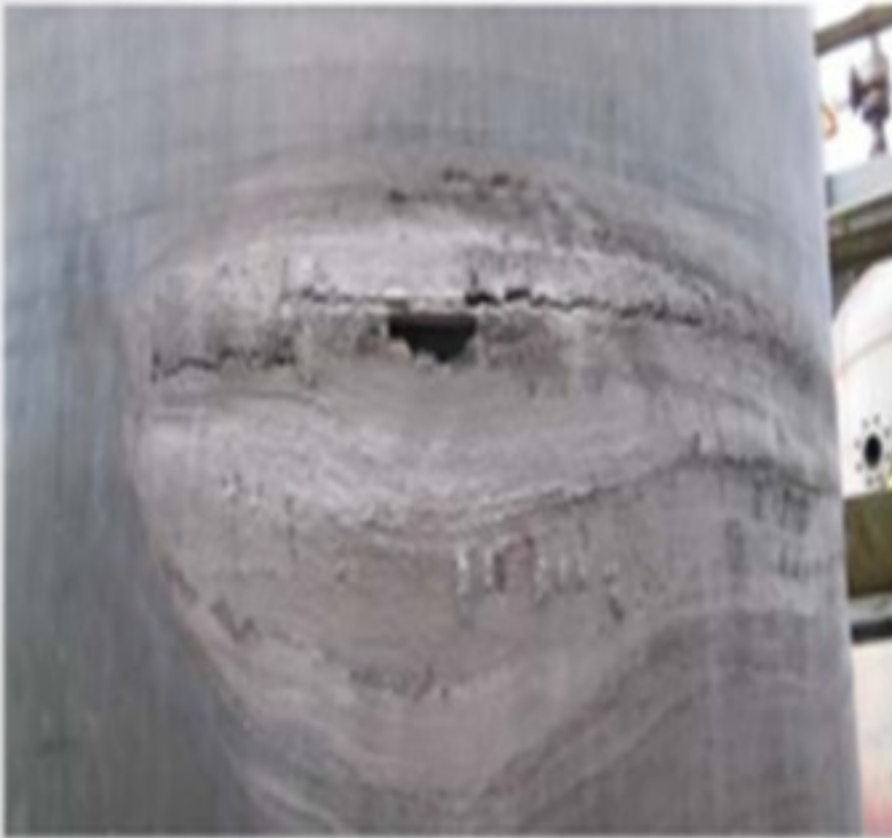
In a refinery where I used to work, our moving-bed reformer experienced a severe temperature excursion in the chlorination zone of the regenerator. After a prolonged outage on the regenerator, the unit was put back into white burns sooner than would have been recommended. On introduction of air/oxygen into the chlorination zone, temperature indicators in the drying zone spiked over 2,000°F, and one of the temperature indicators burned out. Although operation was attempted for a few days beyond the temperature excursion, the unit eventually had to be shut down and the regenerator inspected.

- Severe temperature excursion in chlorination zone of regenerator for moving bed reforming unit.
- Unit put back in “white burn” sooner than what would normally be recommended.
- Drying zone thermocouple indicated temperature spike over 2000°F – believe temperatures exceeded 3600°F.

Upon inspection, it was found that the center screen had failed, as shown on the slide.

- Failed center screen in regenerator

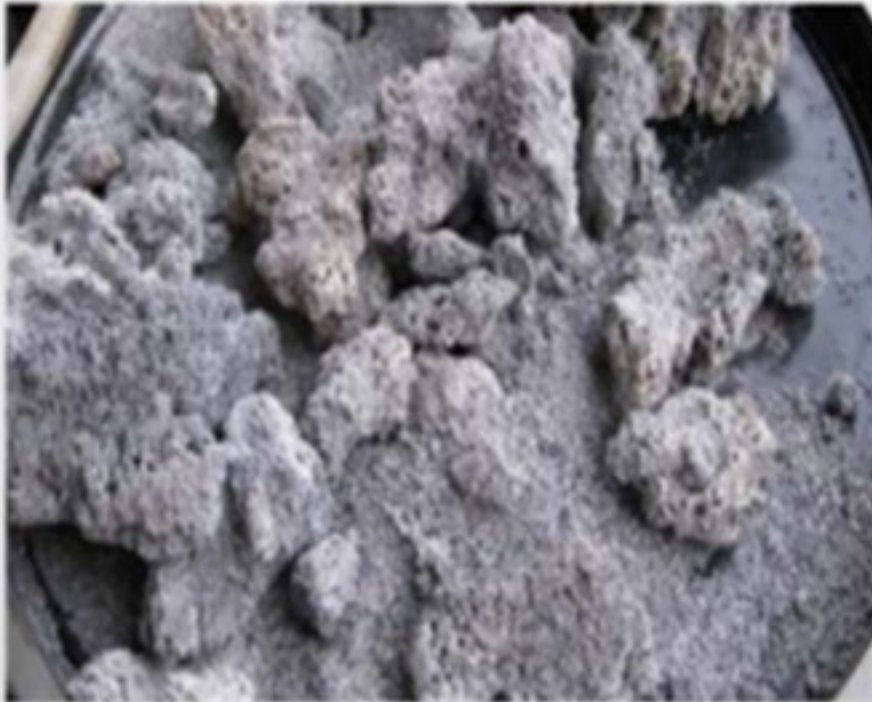
Also, fused catalyst was discovered in the unit. It is believed that temperatures exceeded 3,600°F during the excursion.

- Fused catalyst found in regenerator
