Question 65: Please share experiences in crude tower fouling from organic and/or phosphorous-containing deposits.

2013 Crude/Atm. Distillation & Coking Q&A Session

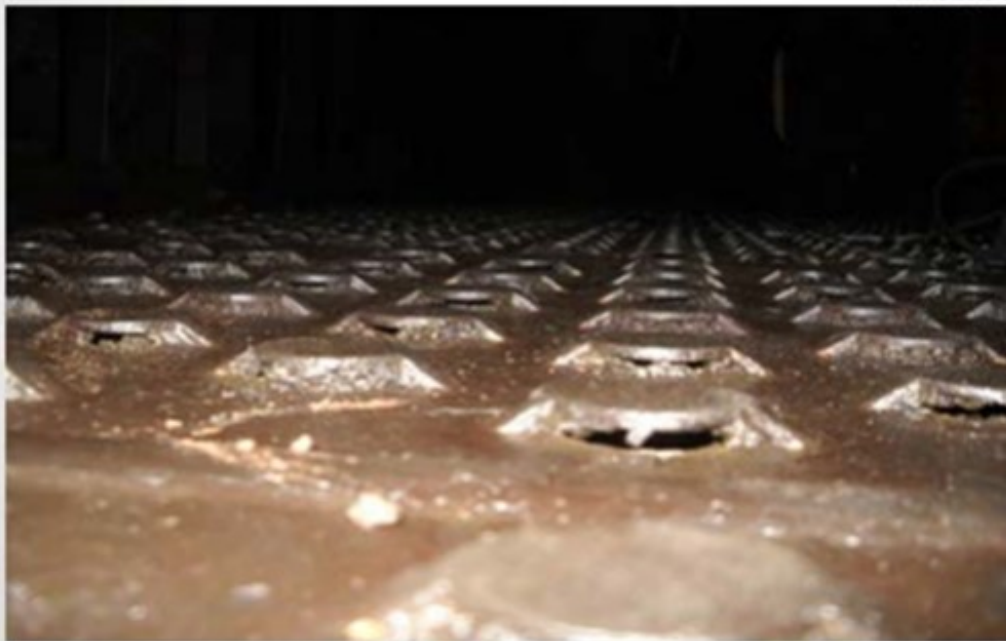
**Fouled Crude Atmospheric Tower Tray
above the Kerosene Draw**

The pressure/level fluctuation intervals started getting shorter between events. We then took a look at the tower and at the common places where plugging could be seen, like in the top trays where you could have some salting if your salt point calculations were not right or if you were too cool. We ensured that we were 20°F ΔT (temperature differential) away from the salt point and ruled that out. We performed a tower scan and found that just above the kerosene product draw tray, there was some non-uniform plugging. Part of the tower would fill up, and part of it would dump. It was a very strange phenomenon which was not uniform across all four passes of the trays.

Here are two pictures showing observations of what we saw when we went in the tower at turnaround. This first two slides show a portion of the tray above the kerosene draw. Observe the fouled material that was plugging the fixed valves. This fouling material there is substantial.

The next slide shows some of the samples taken by our engineers. We had it analyzed, and this is what we saw: carbon, oxygen, and that last component: phosphorous. That is really why we believe this was phosphorous organic fouling in this section. At turnaround, we made some modifications. We replaced the trays with some low fouling trays. We also replaced the top pumparound return distributor. Since that startup, we have not seen any degradation in this section. We feel those modifications will get us through the run.

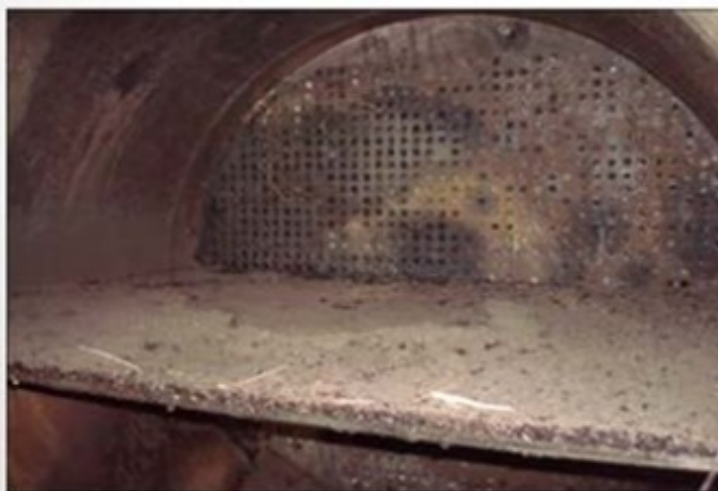
Pumparound Tube Sheet Phosphorous Fouling

In one of our plants, we had a very similar event with flooding in the kerosene section. It manifested as a downcomer problem. We scanned the tower and conducted other normal troubleshooting activities. We also consulted our friends at the Canadian Crude Quality Technology Association. They had seen very similar problems in the past and indicated phosphorous fouling, which is exactly what we discovered upon entry. We also found significant fouling in the pre-heat train. I have a couple of pictures here in the next slides.

On the next slide, you can see how the trays looked when we opened the tower.

- Mitigation
 - Unsuccessful on-line organic acid wash
 - Upgraded kerosene, diesel, and preflash bottom sections to fixed valve trays

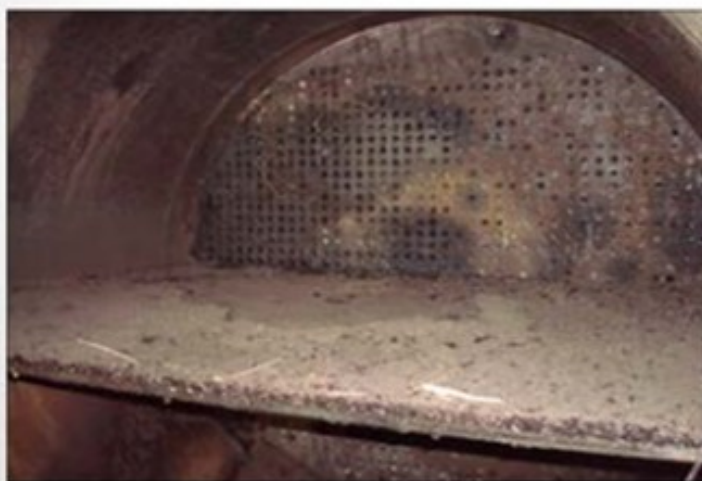
Pumparound Tube Sheet Phosphorous Fouling

The last slide shows fouling in one of the heat exchangers.
