## **Question 72: What are potential causes of damage to the top section of coker main trays? What mechanical and process considerations are used in designing the top section trays for more reliable operation?**

Q-72

2013 Crude/Atmosum Distillation & Coking Q&A Session

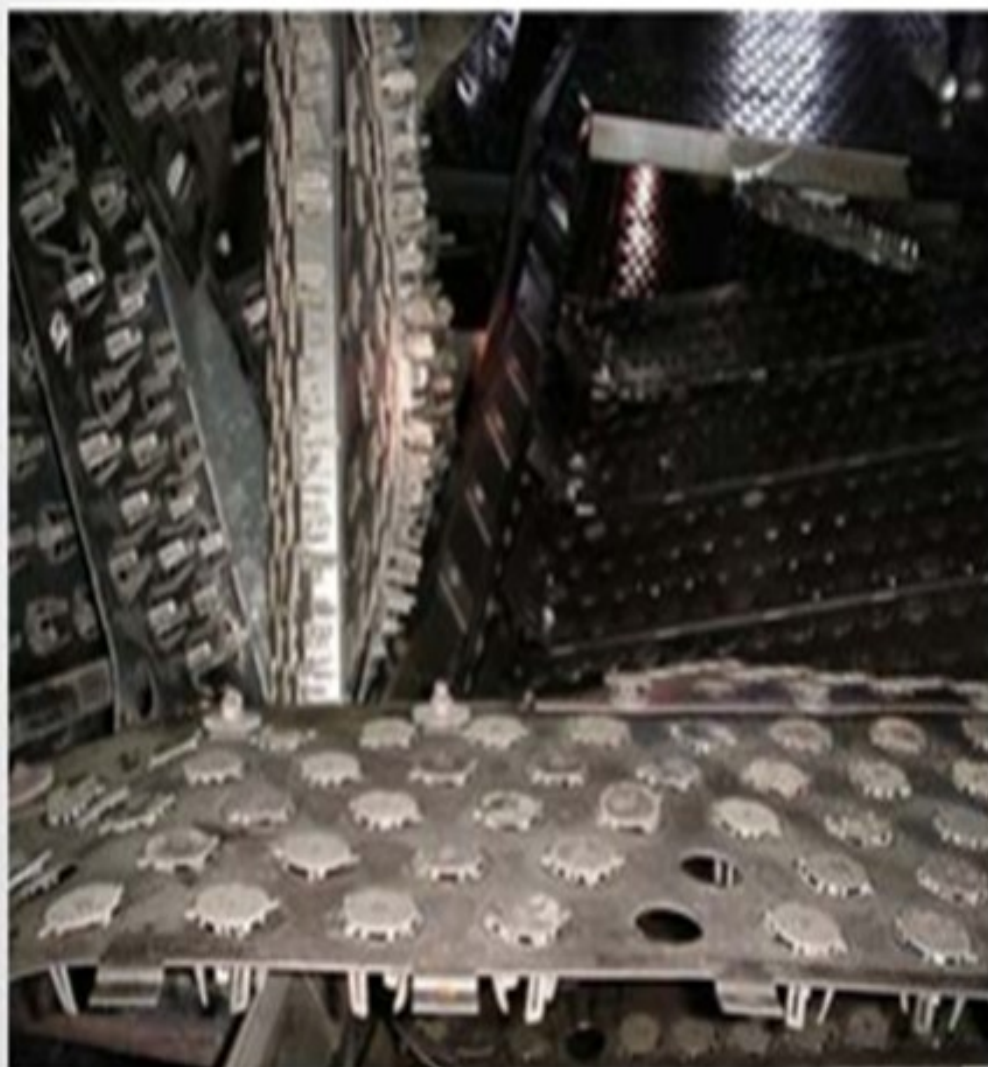
## Damage to Fractionator trays

Increasing the overhead temperatures is probably one of the better ways to control salt deposition and prevent the salts from precipitating in the trays. You could also balance the heat removal between your overhead condenser and the pumparound streams. If you have a low naphtha endpoint, a backend naphtha splitter could be used. Finally, the fractionator overhead drum has to be designed for adequate hydrocarbon and water separation. Operational issues can occur when water is introduced into the fractionator, which then causes a blowout of the vaporized water. We know of one instance during a startup operation when the spare LCGO pumparound pump, which had not been completely drained of water, was started. The rapid expansion of the vaporized water caused by the high temperature in the fractionator blew the top section of the trays between the LCGO section and the overheads. These slides show that event.

Operational issues occur when water is introduced into the fractionator causing a blowout of the vaporized water. We know of one instance during a startup operation when the spare LCGO pumparound pump, which had not been drained completely of water, was started. The rapid expansion of the vaporized water caused by the high temperature in the fractionator blew the top section of the trays between the naphtha and LCGO sections in the fractionator. Below are photographs showing the damage.

That is the real risk of tray damage comes from pressure surges from below. Risks from water wash introduced in the naphtha are relatively modest to low. You should not let that perception of risk prevent you from waterwashing the tower. If you damage trays more than once during water washing, you should really investigate your procedures around how you are adding the water. You should also look at mechanical solutions that make the trays much stronger. These are relatively inexpensive. However, the procedures and operational issues count as well.
