# Question 10: What causes metal-catalyzed coking (MCC) that obstructs catalyst circulation in CCR reformers? What actions do you take to mitigate MCC formation?

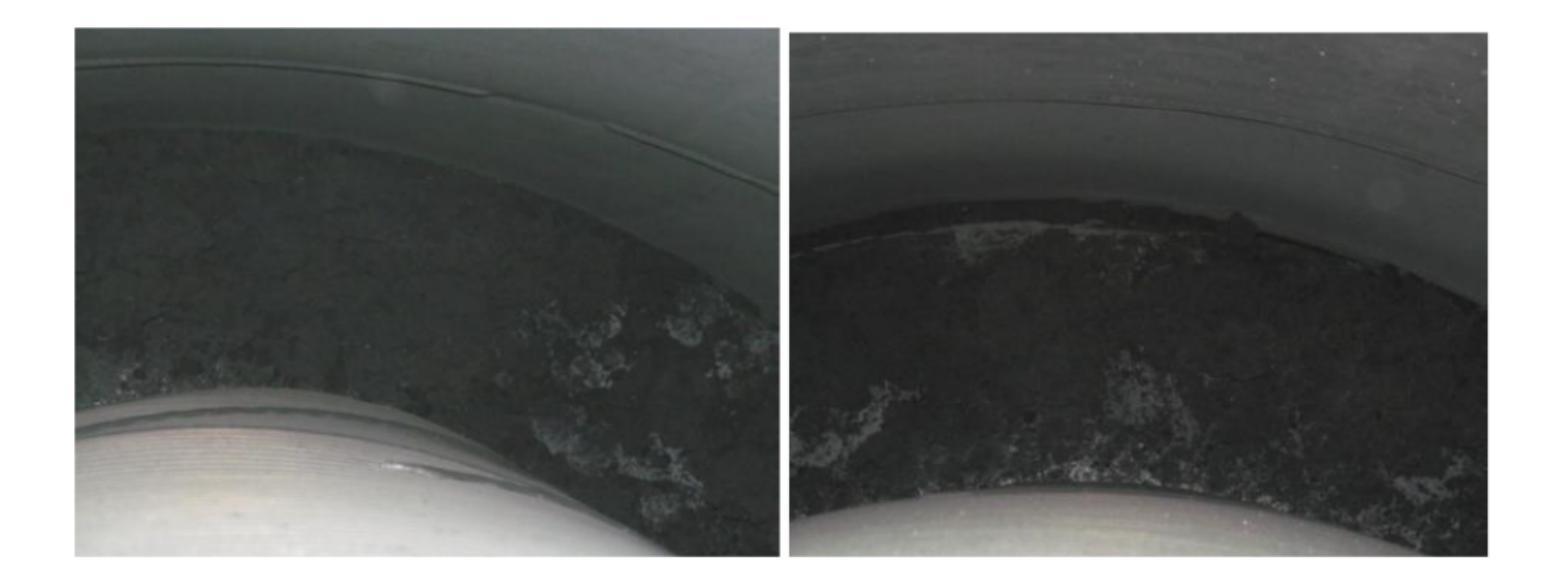
In view of the above issues, it was decided to shut down CCR during March-April'2014 and inspect reactors. Significant unexpected damage of reactor internals was found.

Picture-1: Huge quantity of coke in annular space between reactor grid and shell

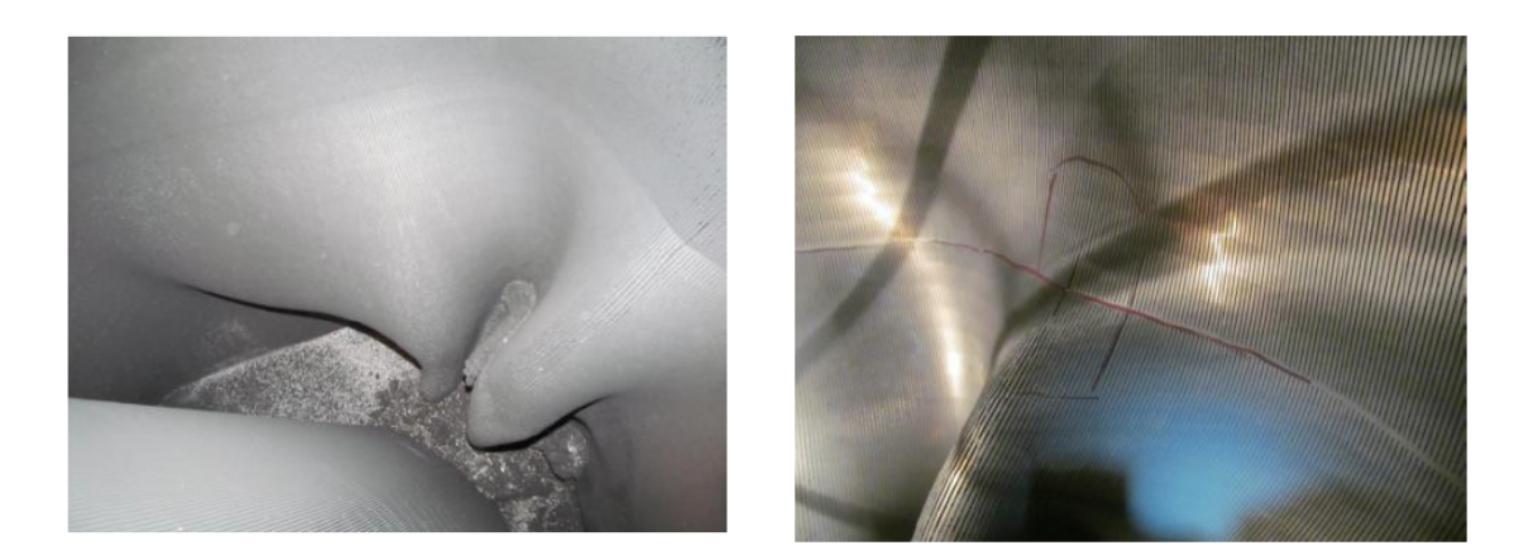
Picture-2(a): Last panel of outside reactor grid found fully bulged with huge coke build up

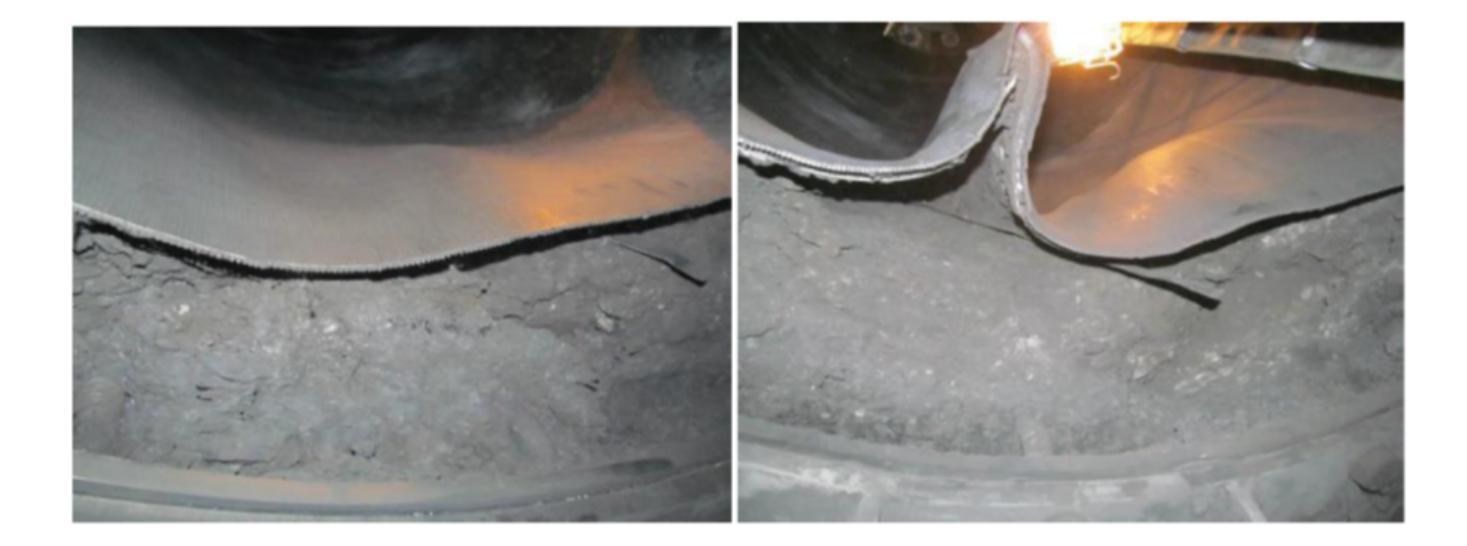
Picture-2(b): Last panel of outside reactor grid found fully bulged with huge coke build up

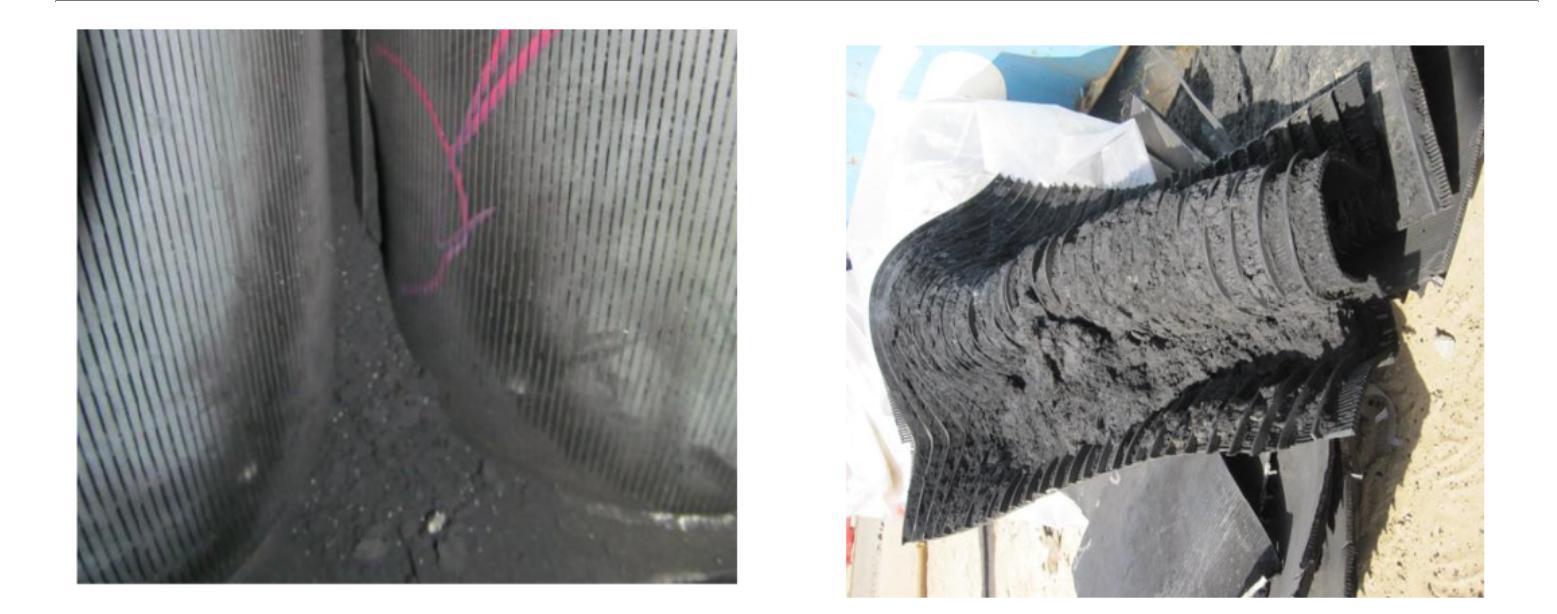
Picture-3(a): Shiny coke between and inside scallops leading to bulging and fish mouth cracks

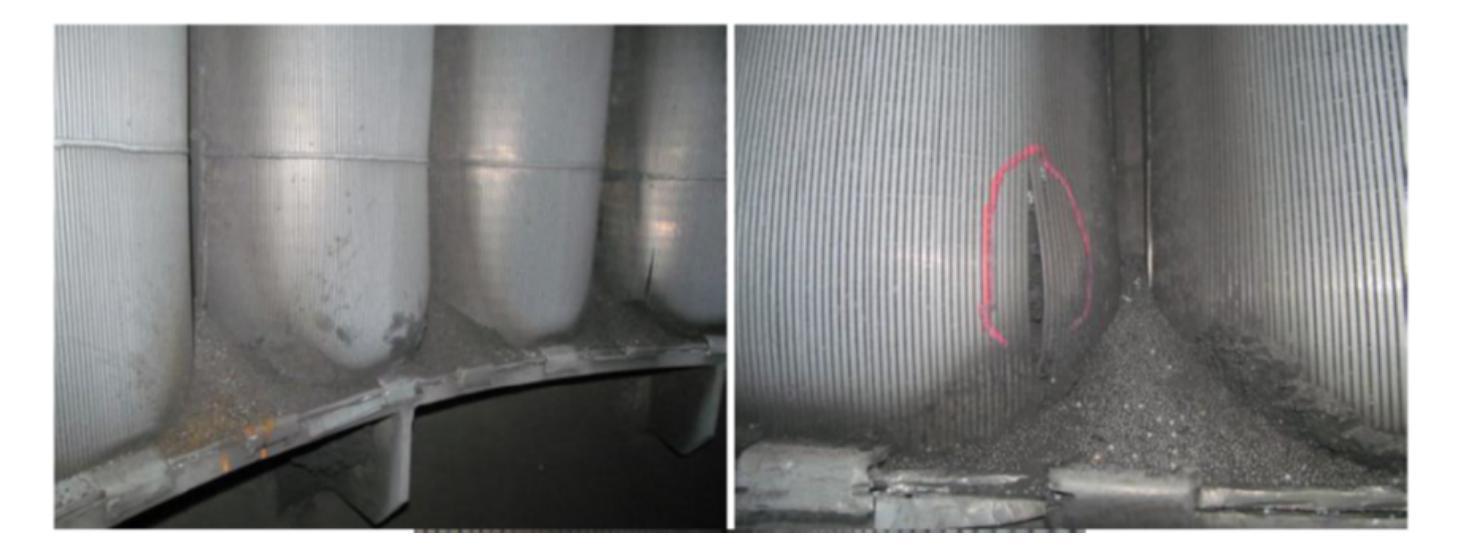
**Picture-3(b):** Shiny coke between and inside scallops leading to bulging and fish mouth cracks A joint root cause analysis with Licensor confirmed presence of Fe and carbon graphite (high carbon content) in the coke samples. During cleaning of the scallops, presence of lot of hard shining coke (metallic coke) was observed along with soft coke. It was concluded that coke build up in reactors/scallops/grids may have taken place due to metal catalyzed coking considering problem with DMDS dosing pump during initial year of commissioning as well as due to other reliability issues like frequent trip of recycle gas compressor. The presence of metallic coke in reactors may have acted as nuclei and further catalyzed the coke growth during recycle gas failure.

Maintain sulfur level 0.3 to 0.5 ppmw on CCR feed to be substantiated by presence of detectable amount of H2S in recycles gas and 100-150 ppmw of 'S' on catalyst sample.

Operate Naphtha Hydro-treating (NHT) unit to remove essentially all of the sulfur and other contaminants in the feed. Inject DMDS in CCR feed through dedicated facility to maintain recommended range of sulfur.

No flame sweeping/scattering on the furnace coils.

Maximum Tube Metal Temperature (TMT) to be restricted below 620oC.

Operation of heater burners within the design regime (maximum allowable process absorbed duty per burner: 1.0 Gcal/h).

Perform positive material identification of tube metal to confirm P9 (confirmed).
