Question 42: In your experience, what are the typical causes of damage to the top of the regenerator inner screen?

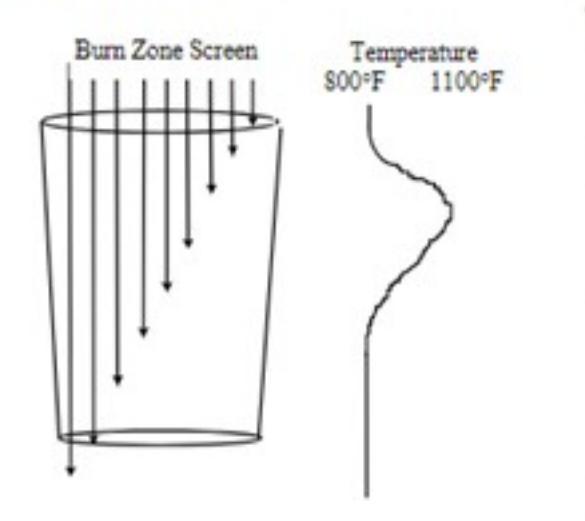
Typical Burn Zone Temperature profile

The typical cause for damage in the top 2-3 ft of inner screen is metal fatigue due to thermal cycling. This is common to all CCR designs, but more critical in early pressurized designs. Catalyst entering the regenerator from the vessel above is relatively cool, from the catalyst lift and elutriation. The cold catalyst enters the regenerator and the regeneration gas at the top of the screen will cool as it passes through this top section of catalyst, then in turn the gas will cool the inner screen.

As the carbon burn begins, catalyst temperature will increase thereby causing the inner screen temperature to rise. Each time catalyst cycles, a thermal cycle at the top of the regenerator inner screen will occur.

Catalyst circulation rate plays a part in the amplitude of the temperature cycle at the top of the inner screen. Lower catalyst circulation rates lead to larger cycles and increased fatigue. The same is true for shutdowns that occur during normal operation at any catalyst circulation rate.

The increased amplitude of the thermal cycle at lower rates can be problematic for CCR units operating at lower reactor severity. Consideration should be given to metal fatigue when determining how to operate in a low coke make regime.
