**Question 15: What can be done to mitigate foaming and emulsion formation in our hydrotreater high pressure separator? Is there any favorable experience with injection of antifoam/chemical emulsion breaker?**

## Mitigating Foam & Emulsion Formation

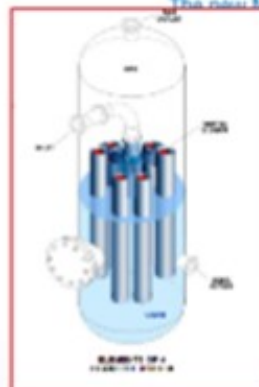
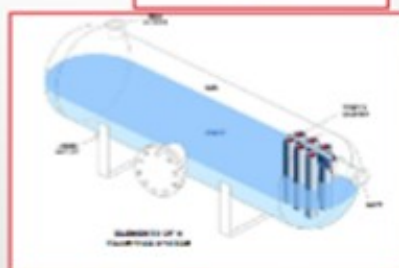
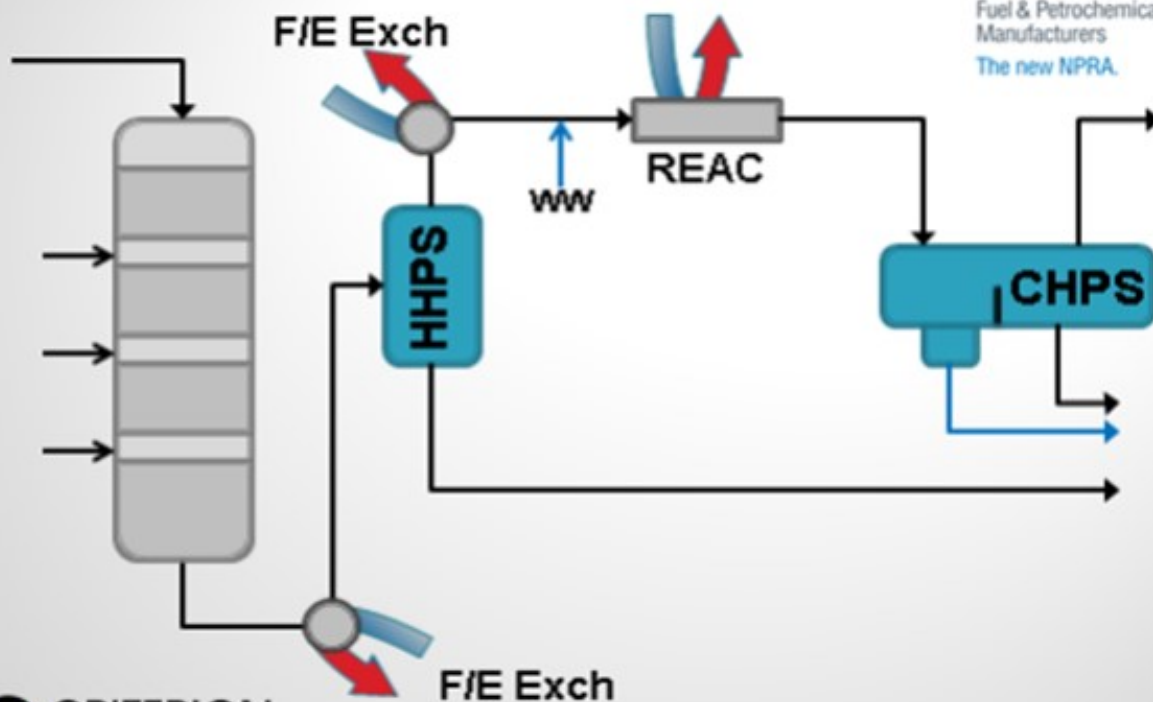
One example occurred when we worked with a company by the name of EGS. They design and manufacture Vortex Tube Clusters, which are a variant of a hydroclone. Although it is a little hard to see

on the diagram, these tubes basically sit down within the liquid, which forces the vapors to go through the tubes. By going up and through the tubes, the emulsion is broken, thereby giving you the benefit of not only minimizing the foaming but also reducing the hydrogen undercarry. So with this particular client, we provided some of the process data because we were doing unit operability improvement work; EGS developed the revamped design. The client saw such a significant reduction in the gas losses that they were able to increase severity and throughput, thereby relieving the hydrogen constraint. So to summarize: Look at your plant data, and do some test runs. But for all intents and purposes, you are probably going to have to do some type of a modification to your separation equipment.

- KBC and EGS Systems, Inc. assisted in client revamp
  - KBC provided process data
  - EGS provided design
- Results
  - Reduced gas losses substantially
  - Increased hydrogen utilization
  - Payback matter of months

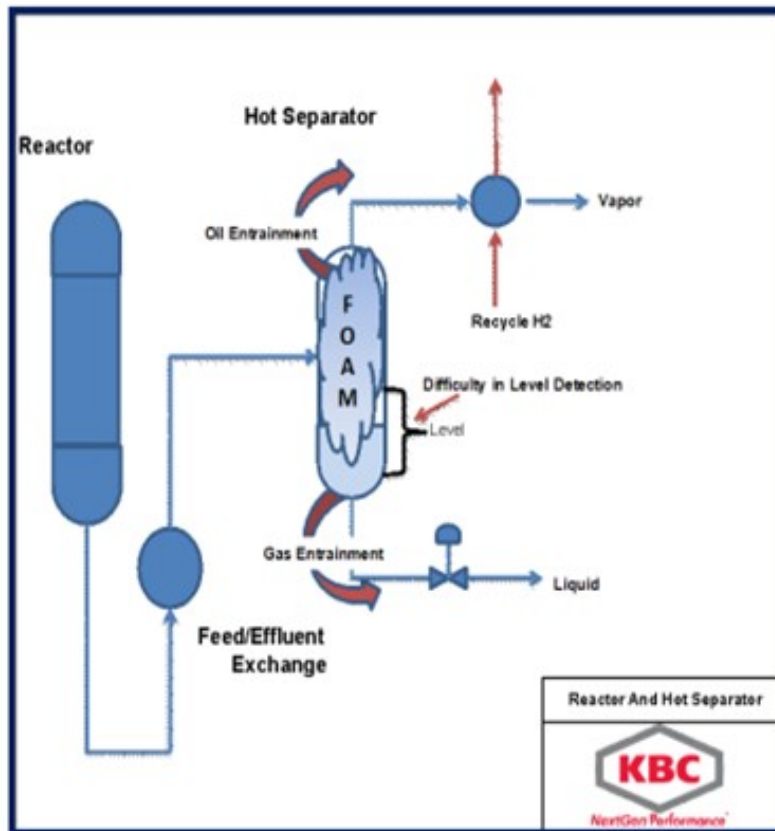
The following is a typical reactor and hot high pressure separator design showing foaming potential and the ability of oil to leave with the vapor and gas to leave with the liquid:

- Density between gas and liquid favors the separation.
- Interaction between the liquid and gas forms a stable fluid or emulsion/foam.
- Gas is entrained with the liquid and leaves in a higher concentration than pure component solubility will predict.
- The result is the separation that does not match design and recoverable hydrogen leaves with the liquid.

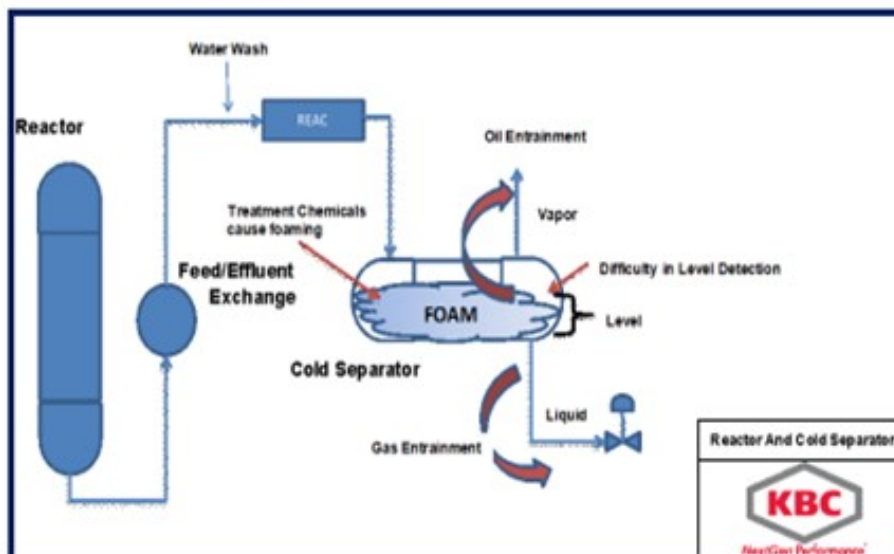
Similarly, designs with cold separators may also experience foaming with oil and gas entrainment, as shown below:

- Hot Separators
  - o Inadequate separation capability increases with throughput or recycle gas rate,
  - o High content of polynuclear aromatics (PNAs) in hydrocracking seems to form stable emulsions, and
  - o High asphaltenes in feed, particularly when processing deasphalted oil (DAO) or resid.
- Cold Separators
  - o Chemicals in injected washwater,
  - o Exchanger leaks, and
  - o High temperatures in separator.

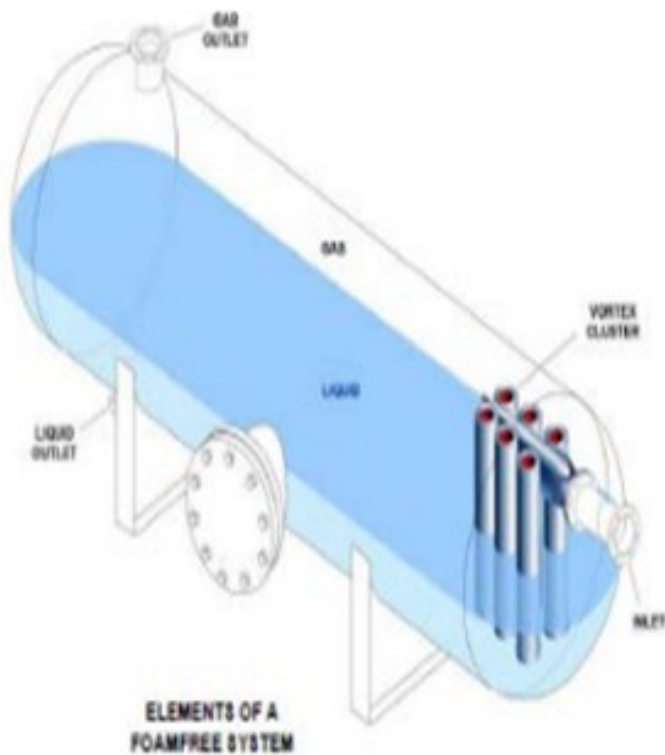
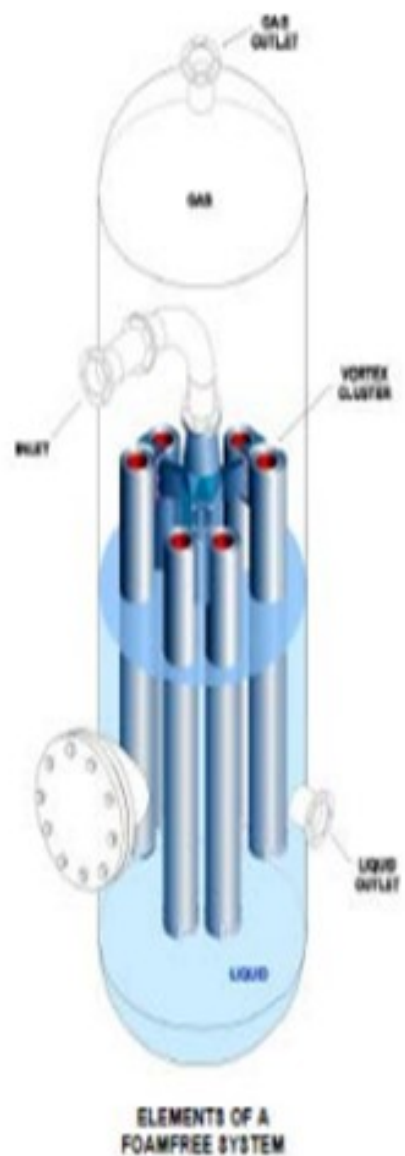
significant separation problems in a resid hydroprocessing unit, KBC partnered with EGS Systems, Inc. to revamp a high pressure separator, with KBC providing the necessary process data and EGS providing the design. The primary revamp involved installation of vortex tube clusters (inlet defoamer) internals. The advantage of these designs is no change is made to the high pressure containment vessel. The cyclones are internally supported, and no attachment welds are required.

The following schematics, courtesy of EGS Systems, Inc., provide generic examples of these vortex tube clusters installed in a horizontal and vertical separator.

For this particular installation, the revamp greatly improved separation, such that the entrained gas losses decreased dramatically and unit hydrogen utilization increased. Therefore, the economics payback was a matter of months, not including the impact of foaming and emulsion reduction. KBC's experience is foaming and emulsion problems require some modification or upgrade to the high pressure separators to improve oil/water and vapor/liquid separation. As a final note, foaming in the amine contactor within the high pressure loop was excluded from this response, as this topic has been covered extensively in past NPRA proceedings.
