Question 18: What are your methods to mitigate bed 1 pressure drop without a unit skim? How would your approach be different if the pressure drop developed in a different bed, say bed 3?

Managing Increasing Reactor Pressure Drop

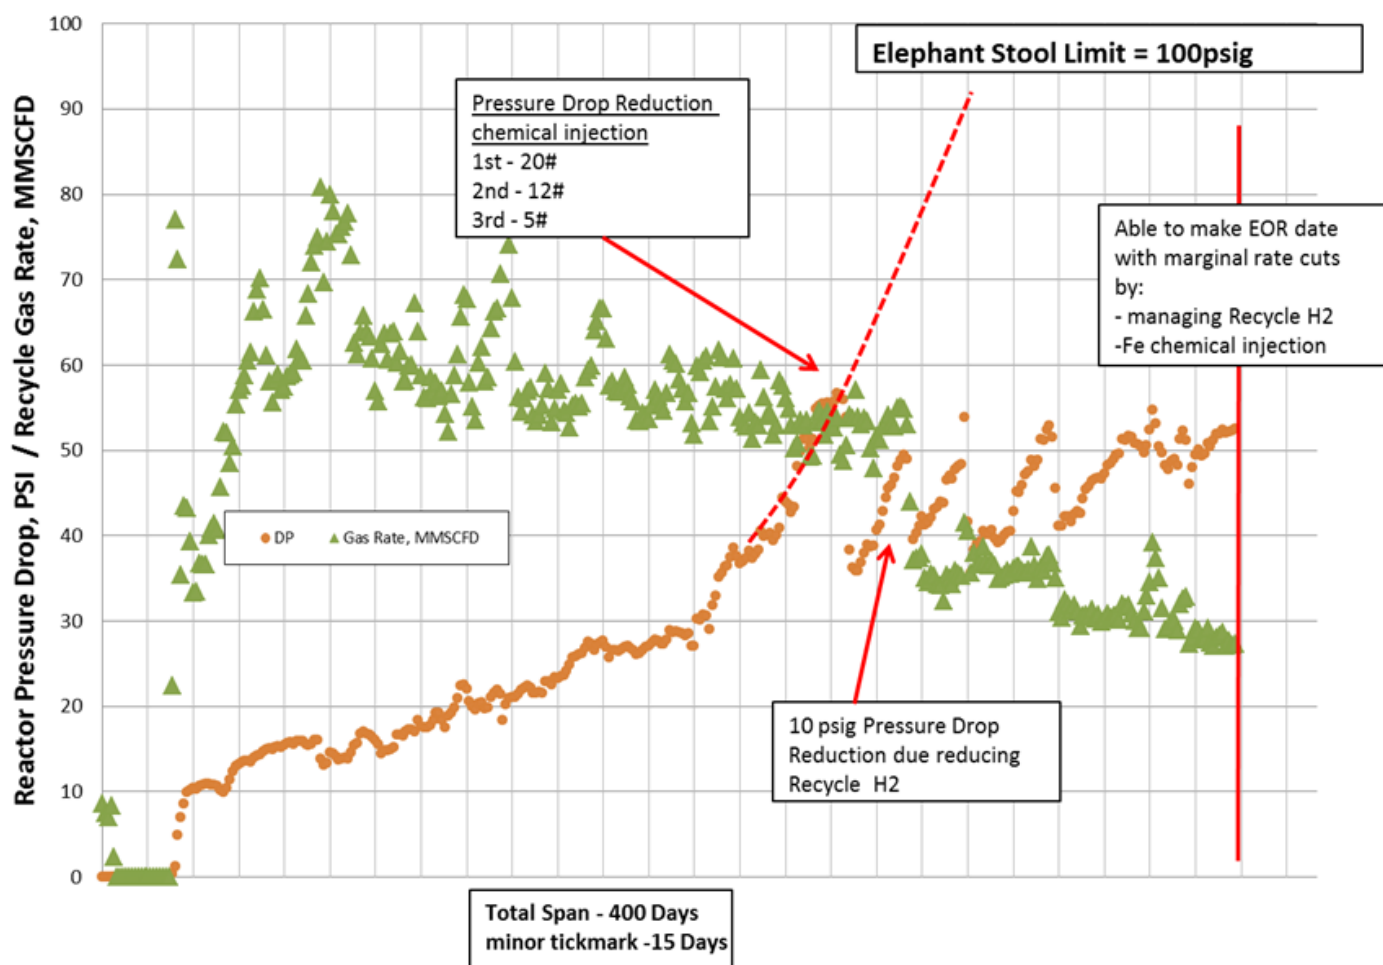
For example in a Naphtha Hydrotreater, both recycle H₂ and Fe Injection agglomerant chemistry was used to extend cycle length. Compressor spillback was used to reduce hydrogen forward flow (caution need to ensure compressor stays away from surge).
