Question 2: Iron is one of the most common contaminant metals seen on naphtha reforming catalyst. What is the source, what is the impact to yields and operation, and what can be done to mitigate these effects?

2017 Summit Gasoline Processes Q&A

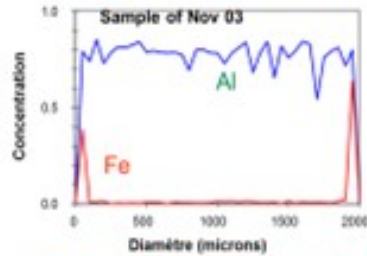
Iron – Source Matters

Electron microprobe delineates iron's location

Local Fe content analysis

Analysis of element's distribution along diameter of the bead

from corrosion scale: **less toxic**

Feed soluble: **toxic**

As mentioned, the first of the two types of iron we see is what we call atomic iron, which is based off metal content or due to heater tubes. It is a smaller iron particle. With atomic iron, we see a much higher penetration of iron into the center of the bead. This slide shows an electron microprobe of a catalyst. We would envision it this way with the left side being one side of the catalyst bead; the right side is the far edge with the center being the middle of the catalyst. What we see with atomic iron is that the iron penetrates much further into the core of the catalyst and is much more detrimental to the performances. Corrosion byproduct-based iron peaks on the left and right edges, which is equivalent to staying on the surface of the catalyst. So, this iron is less detrimental and not as impactful. It also has the impact of being iron from a corrosion byproduct. You can tolerate a much higher level of impurities – maybe up to 5,000 parts per million by weight (ppmw) – versus atomic iron where you see significant yield penalties starting at 1500 ppmw. So, the type of iron and the quantity of iron do make a big difference.

While there are three main sources of iron contamination, two of them – namely, naphtha feed-based iron and metal dusting-based iron – have increased impact due to the atomic nature of the iron. Atomic iron is as named: individual atom(s) that are more mobile and able to penetrate deep into the catalyst pores. This atomic iron introduces a significant effect at lower concentrations than the corrosion scale iron which deposits on the outer surface of the catalyst.

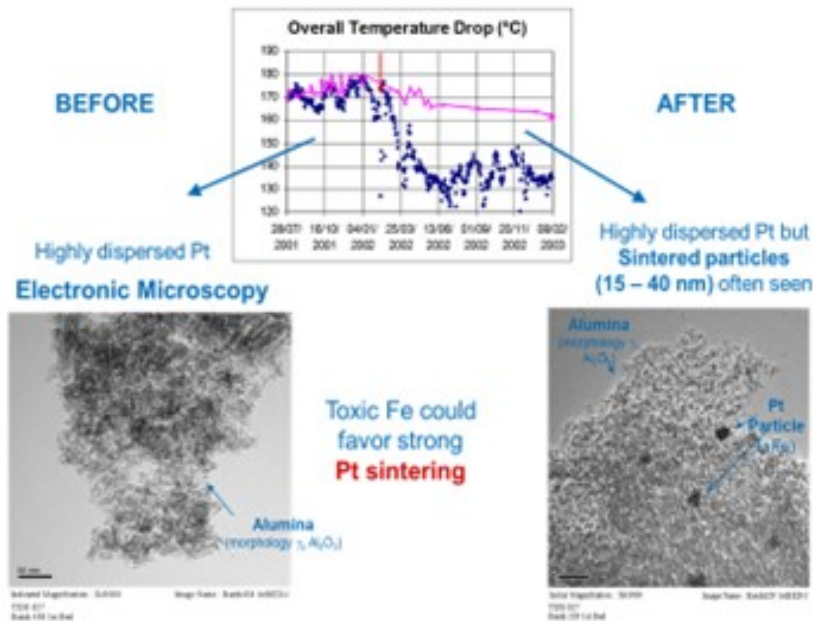
Iron – Contamination Impact

In terms of yields, what we have seen with iron penalties is the ΔT (delta T; temperature differential) of the unit. The total ΔT is shown in blue before and after an iron upset. What we saw was a 20 to 25% drop in total ΔT across the reformer due to the iron. This decrease in temperature observed corresponded with when we took electron microscopy of the catalyst before and after the event and saw platinum agglomeration within the core of the catalyst that was never able to be regained over the course of this cycle. It was a permanent loss of performance.

Impacts of iron contamination, as noted previously, are highly dependent on the type of iron and how it deposits on or within the catalyst. For surface iron derived from corrosion scale, concentrations as high of 5,000 ppmw have been observed with minor impacts on performance. Much lower concentrations of atomic iron, derived from metal dusting or feed sources, has been observed to cause performance and yield impacts at concentrations as low as 1500 ppmw.

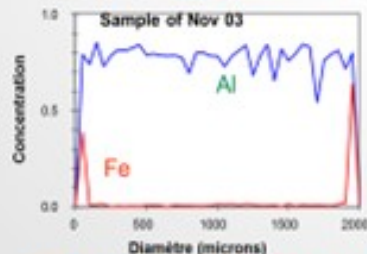
Q2: Iron – Source Matters

Analysis of element's distribution along diameter of the bead

from corrosion scale: **less toxic**
