Question 16: HCl concentration in the reformer net off-gas is being actively measured using hand-held detector tubes. Despite routinely measuring near-zero ppm (parts per million), chloride corrosion occurs downstream. What is the source of this corrosion, and what can be done to better measure and manage the source?

HCI in Reformer Net Gas

2017 Summit Gasoline Processes Q&A

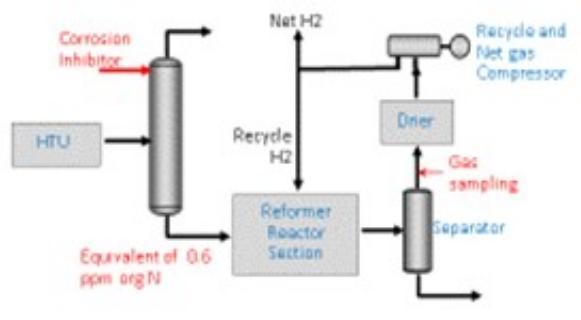
- Cyclic unit: HCl not detected in recycle/net gas while injecting amine based corrosion inhibitor to upstream HTU Stabilizer overhead system.
- Experienced corrosion in unit taking Reformer H2.
- Actions:
 - · Discontinued chemical injection
 - Detected 0.5-1 ppm HCl in net gas
 - Installing net gas Cl trap

The other challenge with measuring CI in the net gas can be due to interference with ammonia. We had an interesting case which can describe such situation. The cyclic reformer was injecting the aminebased corrosion inhibitor to the upstream HTU stabilizer overhead system at the rate which may bring up organic N (nitrogen) in the stabilizer bottoms (reformer feed) to about 0.6 ppmw. At the same time, we had difficulty detecting any HCl in various sections of the reformer recycle gas loop, even though it is a cyclic unit. From its original construction, the unit did not have a CI trap. Despite there being no detected presence of HCI in recycle gas or net gas, the user of the reformer H2 experienced corrosion problems. We knew that reformer H2 should have at least trace of HCI, but we could not measure it. At that point, the site conducted a short test of discontinuing the corrosion inhibitor injection and immediately detected 0.5 to 1 ppmw HCI in the net gas that was using the detector tube. We are now proceeding with the installation of the chloride trap. It is still not clear whether NH3 (ammonia) is just interfering with the detector tube catalyst or if it, in fact, reacts with HCl in the process gas tying it as NH4Cl (ammonium chloride).
