Question 63: Please explain the phenomenon known as "coke ratcheting" in the FCC reactor where equipment exposed to coking services elongates over time and heat cycles. Please provide details of actual examples of where this occurred and the impact to equipment operations and reliability.

### **Coke Ratcheting**

2017 Summit FCC Q&A

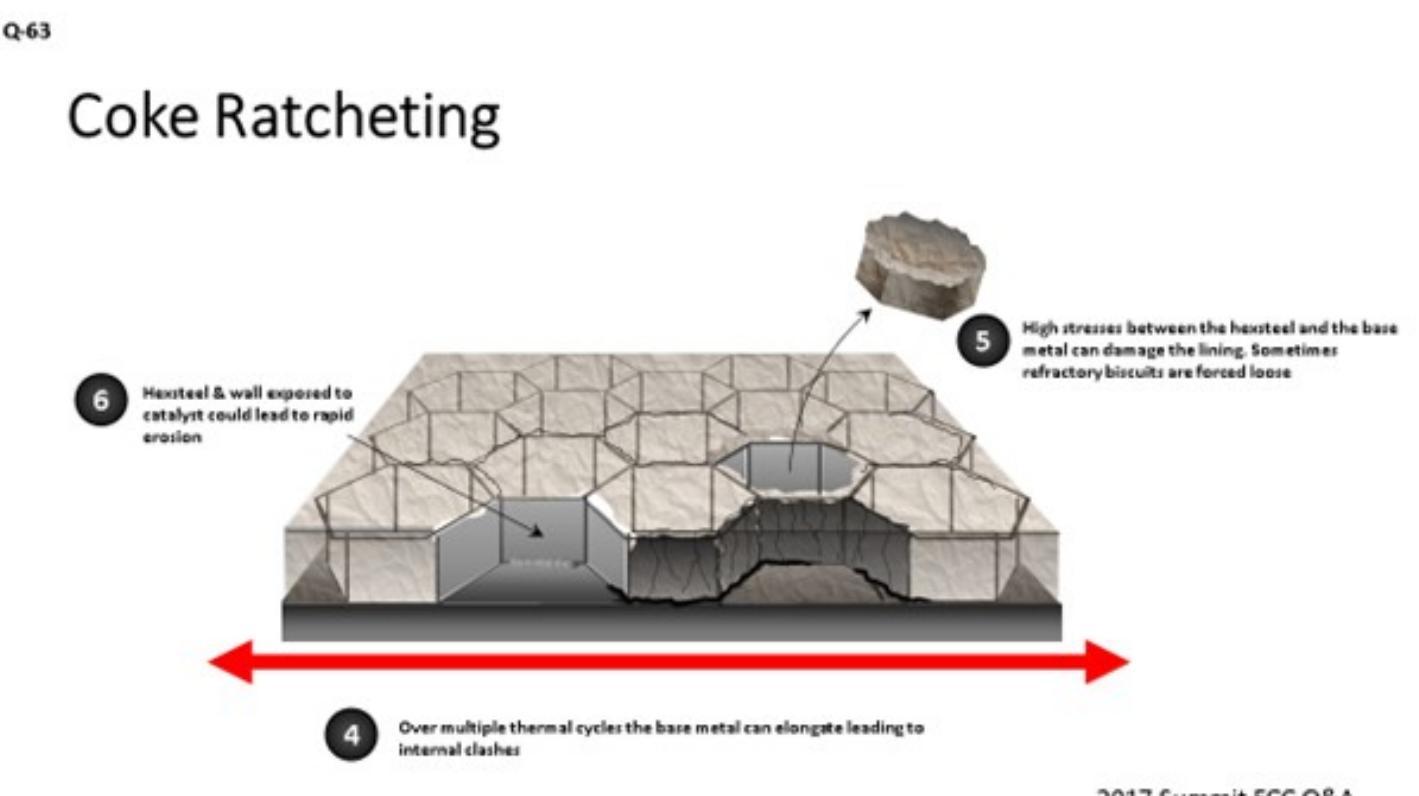
During your next thermal cycle, when the material returns to the 'hot' position, it may be slightly longer. The stresses there between the hex and the base metal then get worse, as do the cracks. Over many, many thermal cycles like this, you can eventually actually extend the base material. We have seen it in riser termination devices and in some areas of cyclones, such as in the crossover areas. What may also happen before you even see the elongation of the base material is that the coke will separate the hex from the base metal. You might see refractory biscuits popping out; and where there is bare metal exposed, you will then see some severe erosion.

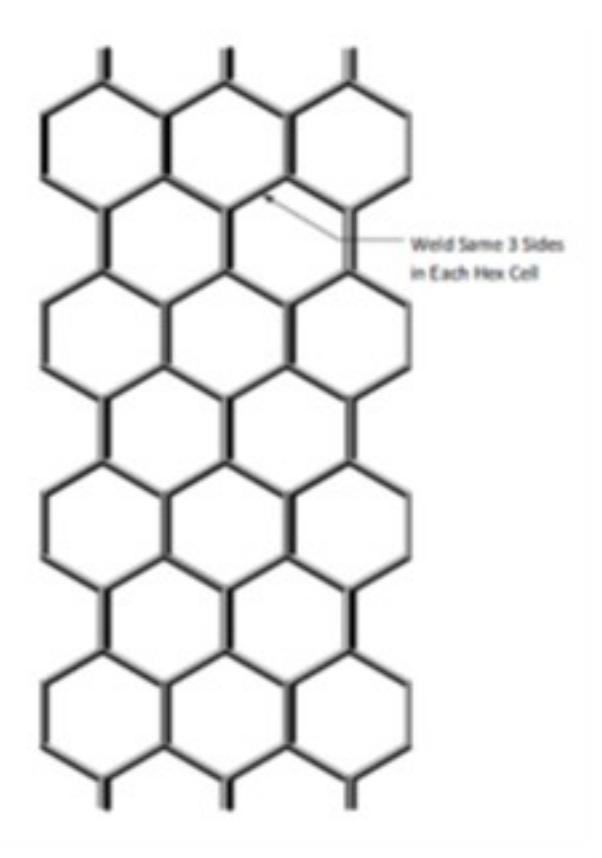
We have seen some liner failures due to coke ratcheting in our reactor/riser systems. For this reason, on abrasion resistant linings in coking service, our standard is to weld the full length of every hex mesh bar, as shown in Figure 1. By welding the same three sides in each hex, every bar receives an attachment weld to the base metal. Since we implemented this practice in 2005, we have had good lining performance in coking service.

Figure 1: Hex Mesh Welding Diagram in Severe (Coking) Service

When the system is cooled down, the coke impregnated lining does not return to its original shape causing the parent metal to yield and elongate. In the cold condition, high stresses are present in the attachment welds between the hex mesh and the parent metal. This situation can lead to lining failures.
