Question 95: What failure mechanisms have you observed in cyclone or cyclone support systems? What is the typical time to failure?

G-95 Failure Mechanisms of Cyclones and Supports

2013 FCC Q&A Session

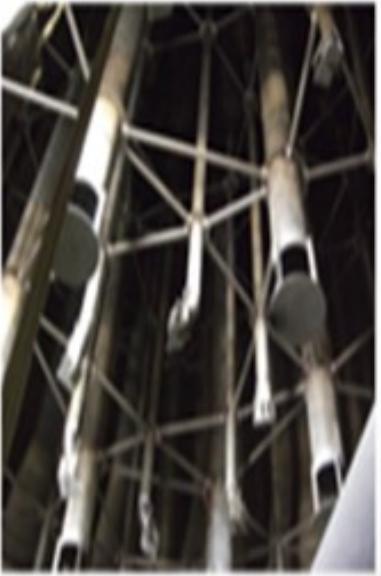
- Observations
 - -Cyclone designs
 - Support systems
 - Change in feed qualities
 - Operation at high vapor and catalyst velocity

Time to failure

- -Length of operation within design parameters
- -Shutdowns and temperature excursions
- Support system
