Question 70: Electrostatic precipitator (ESP) fines handling is often complicated by fluidization and mechanical integrity issues. How often do you experience these types of fines handling issues, and what are some of your Best Practices to successfully mitigate these issues? What are your Best Practices for safe fines withdrawal from the ESP?

ESP Fines Handling

2017 Summit FCC Q&A

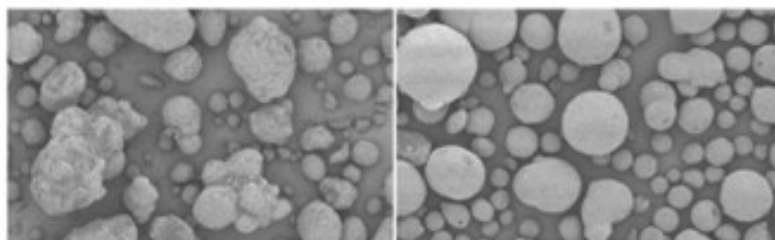
• Catalyst PSD and Morphology

"Bad Morphology"

"Good Morphology"

The morphology and PSD profiles of the ESP fines will have a strong impact on the fine's withdrawal efficiency. Cyclone performance within the regenerator plays a major role in ESP performance and the corresponding fluidization properties of the ESP fines. Healthy cyclone operation typically results in average particle sizes (APS) in the range of 15 to 30 microns, depending on the regenerator design and overall hydraulic profile. Adequate cyclone performance helps maintain a manageable particulate loading to the ESP while sustaining a healthy PSD profile for the ESP fines. Excessive loadings to the ESP, over an extended duration, can have the following impacts:

Excessive attrition within the reactor-regenerator system or the regenerator flue gas train can significantly reduce the APS of the fines, essentially increasing the concentration of microfines and fractured particles. These microfines and fractured particles tend to agglomerate, preventing smooth flow of the ESP fines into the collection hoppers. This type of fluidization issue is more prevalent once the APS of the fines drops below 15 microns. The jagged edges caused by catalyst fracturing can be identified by SEM analyses of the ESP fines samples. Even with a healthy PSD profile in the fines, agglomeration can occur due to other flue gas system failures, such as a flue gas cooler leak. The steam and boiler feed water in contact with catalyst fines can quickly lead to undesired catalyst agglomeration. Further, in extreme cases, acid dew point corrosion may be observed. These types of flue gas cooler leaks can be detected through sudden increases in the process-side pressure and much higher metals deposits on the ESP fines than those of the circulating e-cat inventory. The affected flue gas cooler tubes, or banks, should be isolated as quickly as possible to mitigate further erosion and downstream issues.
